# Manhole Inspection Summary

Manhole # S37AA1027MH

Insp Date: **1/3/07 8:14 AM**

**Location** Address: **629 35TH ST**

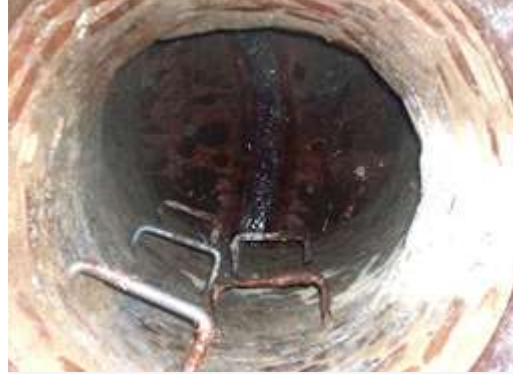
Top View

**Bench** ☒ Exists Material: **Brick** ☐ Parged ☒ **Debris** (not Condition related)  
Condition: ☒ Sound ☐ Cracked ☐ Root Intrusion ☐ Deteriorated ☐ Leaks ☐ Debris

**Steps** Count: **5** Missing: **0** ☒ **Corroded**

Corroded steps. Bench debris.

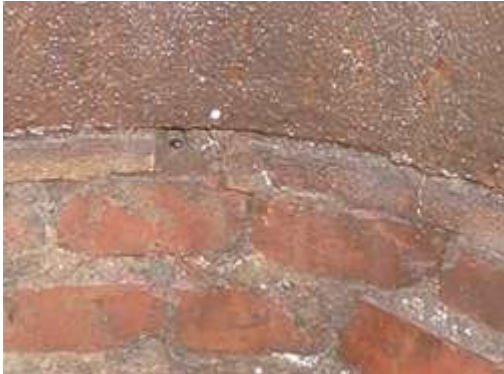
Defect

**Frame** Offset: **0** (in.) Condition: ☐ Sound ☐ Cracked ☒ **Leaks**

**Chimney / Frame Adjustment** ☒ Exists Material: **Brick** ☐ Parged Height: **3** (in.)  
Condition: ☐ Sound ☐ Cracked ☐ Root Intrusion ☐ Loose Brick ☒ **Deteriorated**  
Infiltration: ☐ None ☒ **Joint** ☐ Cracks ☐ Mortar ☐ Roots ☒ **Wall**

Frame leaks. Adjustment infiltration.

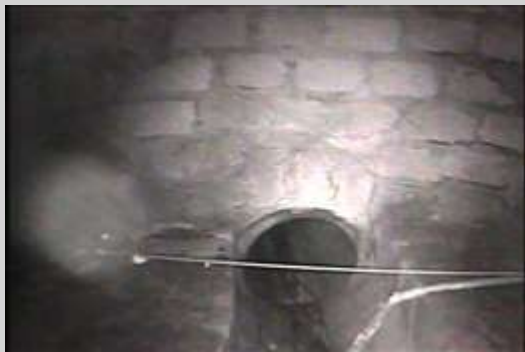
### 8 in. Circular Gravity Sewer Pipe Out @ 12 O'Clock

Infiltration: **Evidence** Pipe Seal Cond: **Unknown**

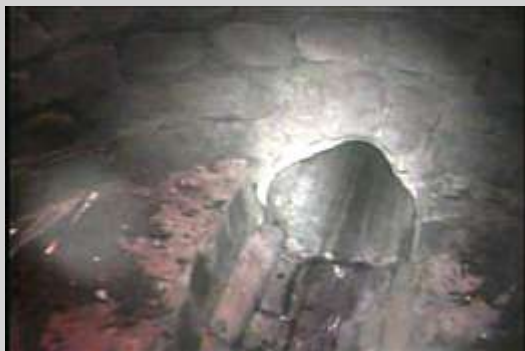
### 8 in. Circular Gravity Sewer Pipe In @ 7 O'Clock

**Barrel** Material: **Brick** ☐ Parged  
Shape: **Circular** Diameter: **46** (in.) Length: **56** (in.)  
Condition: ☐ Sound ☐ Cracked ☐ Root Intrusion ☐ Loose Brick ☒ **Deteriorated**  
Infiltration: ☐ None ☐ Joint ☐ Cracks ☒ **Mortar** ☐ Roots ☐ Wall

Barrel deterioration and infiltration.

Infiltration: **Evidence** Pipe Seal Cond: **Broken**
